Experimental and numerical investigation of cavitation-induced erosion in thermal sprayed single splats

Yan Wang, Bruno Lebon, Iakovos Tzanakis, Yongli Zhao, Kuaishe Wang, Jorge Stella, Thierry Poirier, Geoffrey Darut, Hanlin Liao, Marie-Pierre Planche

To appear in: *Ultrasonics Sonochemistry*

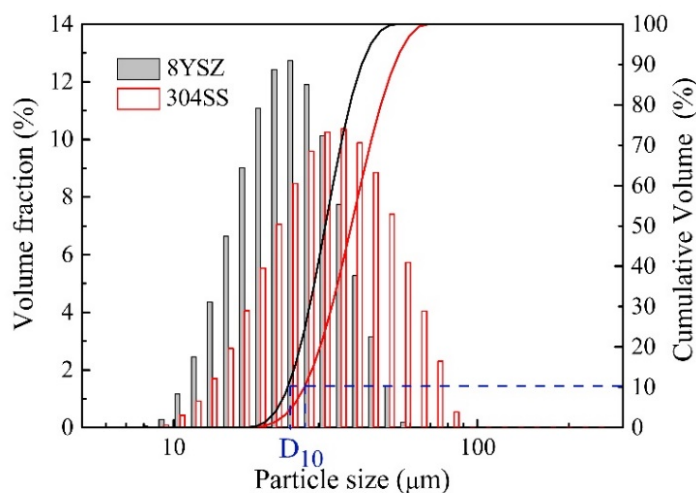
Figure 1: Size distribution of the powders

YSZ (Saint Gobain, France) and 304 SS (LTS Research Laboratories, USA) powders were plasma sprayed on 304 stainless steel substrates. Their size distributions were determined by laser diffraction (Mastersizer 2000, Malvern, England). An average size of $26.8 \mu\text{m}$ was found for YSZ with $D_{10} = 15.7 \mu\text{m}$, $D_{50} = 25.3 \mu\text{m}$ and $D_{90} = 40.3 \mu\text{m}$. The D_{10} , D_{50} and D_{90} labels represent that the volumetric percentage of particles with diameter less than the stated diameter in the subscript. For example, $D_{10} = 15.7 \mu\text{m}$ means that 10% of the total volume of particles have a diameter smaller than $15.7 \mu\text{m}$. The average size of 304SS is $38.1 \mu\text{m}$ and D_{10} , D_{50} and D_{90} are $19.4 \mu\text{m}$, $35.3 \mu\text{m}$ and $61.1 \mu\text{m}$ respectively (**Figure 1**). Materials properties of YSZ and 304SS are presented in **Table 1**.
